Inspected By: Ryan Quader SC Lic# RBI. 48865

Home Inspection Report

123 Example Report Ave.

Inspected on Fri, Mar 4 2016 at 12:00 PM

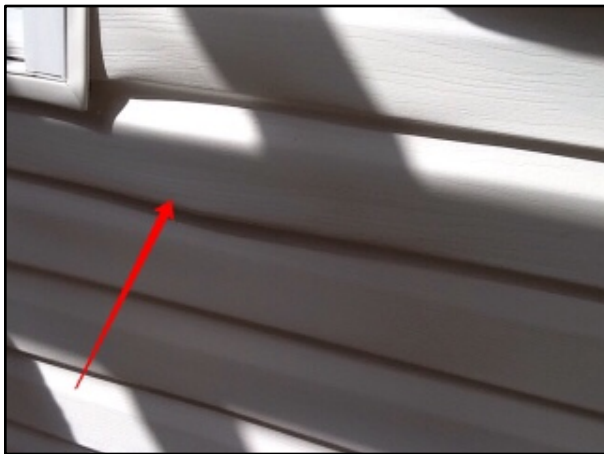
Figure 1-1

Comment 1:
Warped siding near back kitchen window. Cosmetic issue.

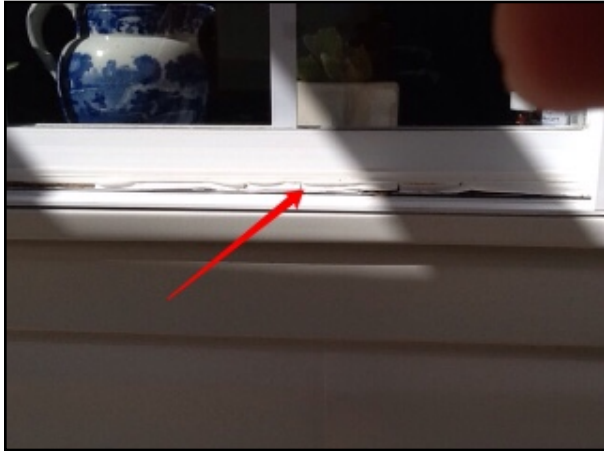
Figure 2-1

Weather stripping on exterior kitchen window is dried out and cracked. Recommend seeking licensed general contractor to further evaluate and repair.

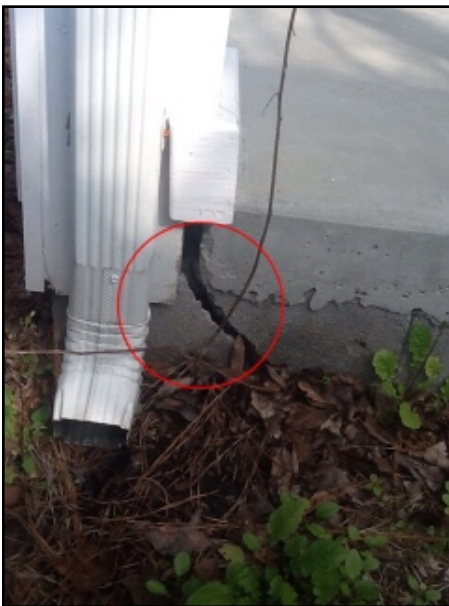
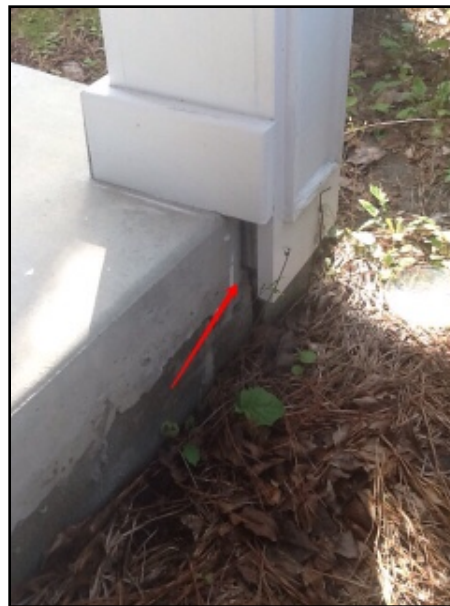
Outside front porch is cracked under load bearing column and is pulling away from main foundation. Located at farthest right column. Recommend seeking licensed general contractor to further evaluate and repair.

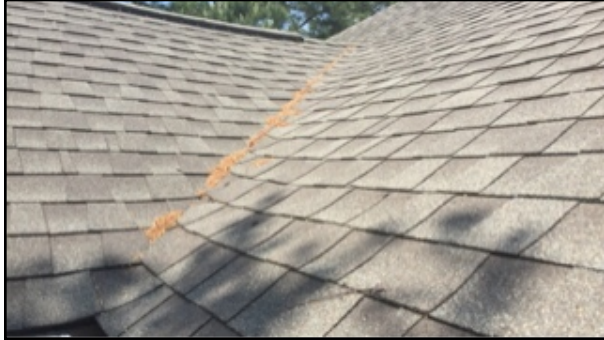
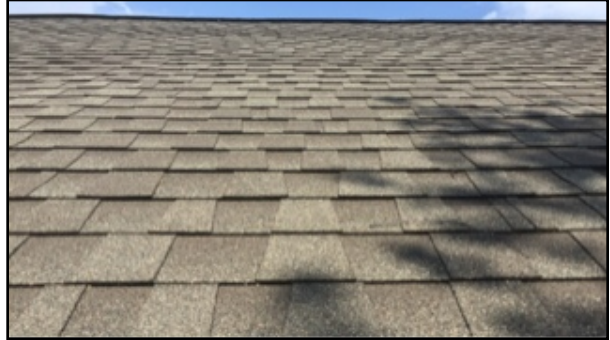
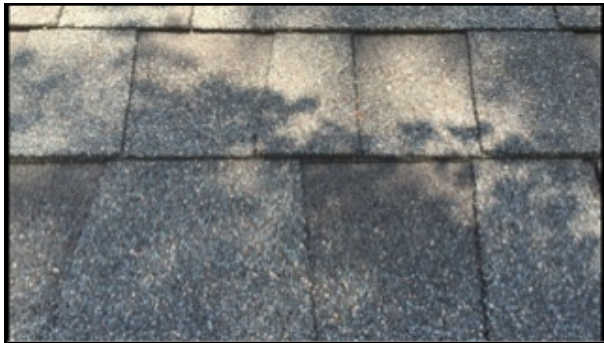
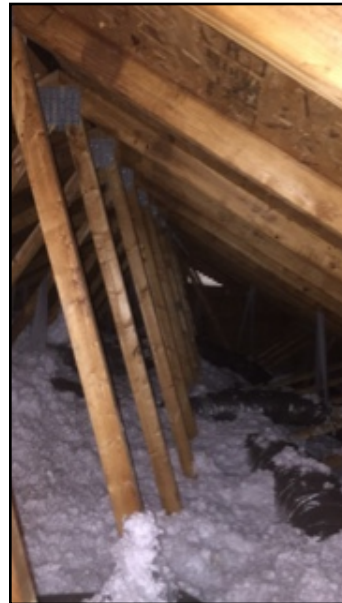
**Comment 5:**
Roof is in satisfactory condition. Truss system is adequately installed.

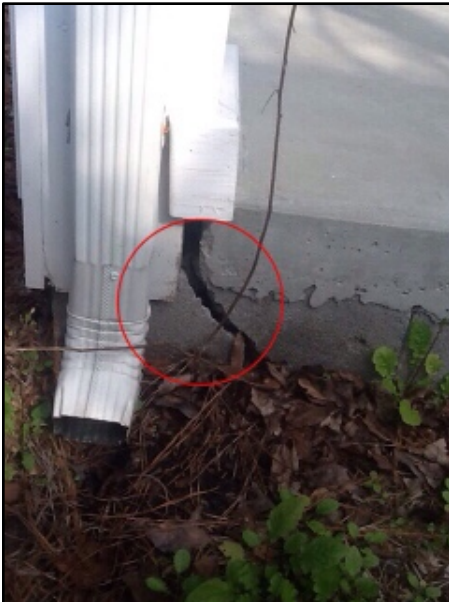
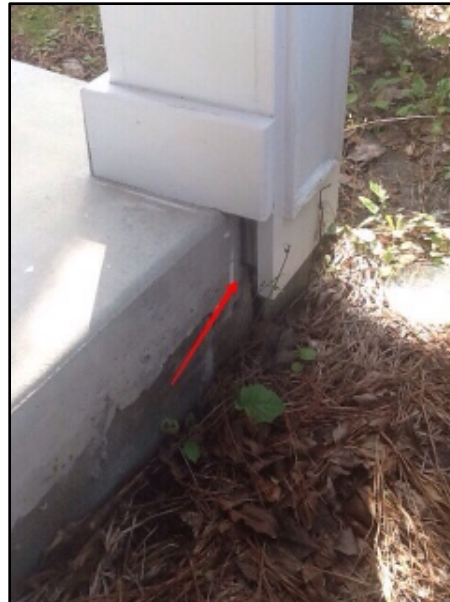
Outside front porch is cracked under load bearing column and is pulling away from main foundation. Located at farthest right column. Recommend seeking licensed general contractor to further evaluate and repair.

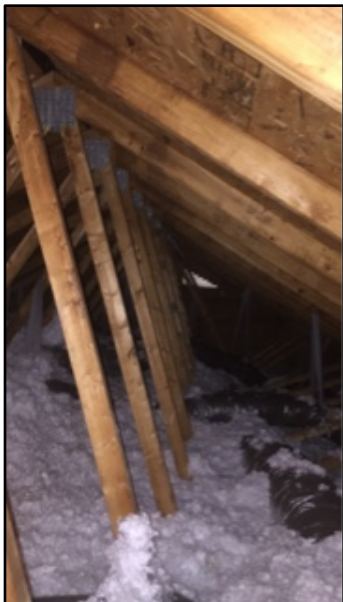
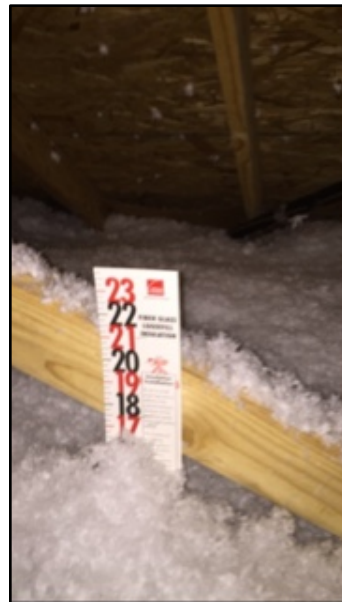
Comment 7:
Insulation is adequately installed.

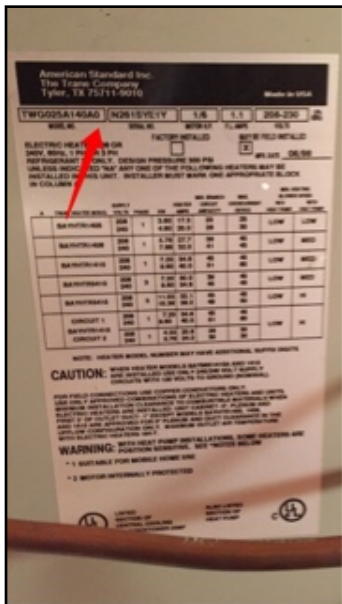
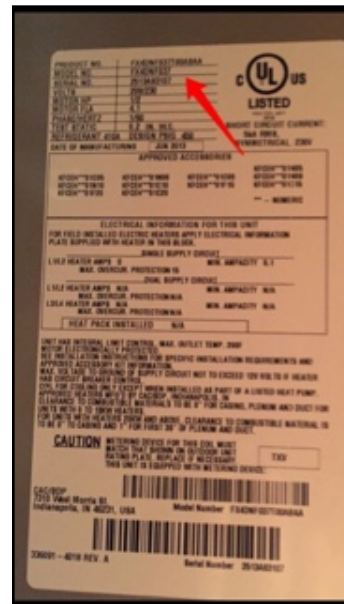
Air handler model and serial

Numbers. 1-located behind knee wall in office. 2- located in attic

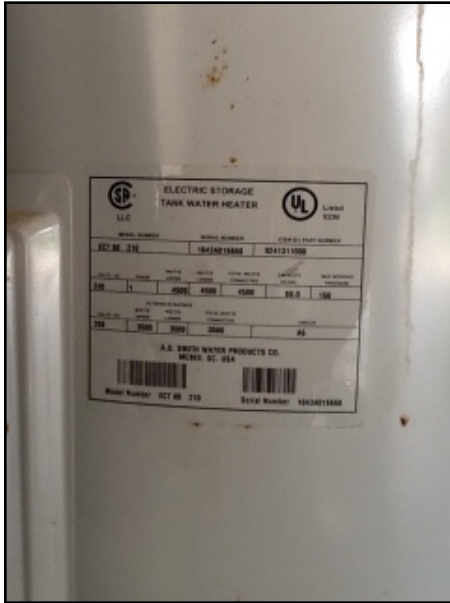
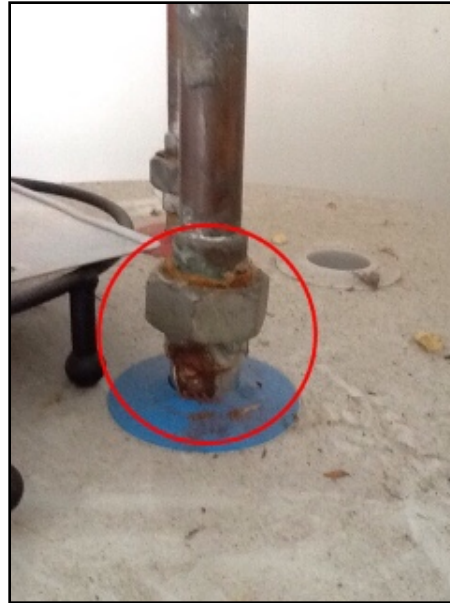
Comment 11:
Serial & model number sticker.

Minor corrosion present to intake supply line. Normal for age & location.

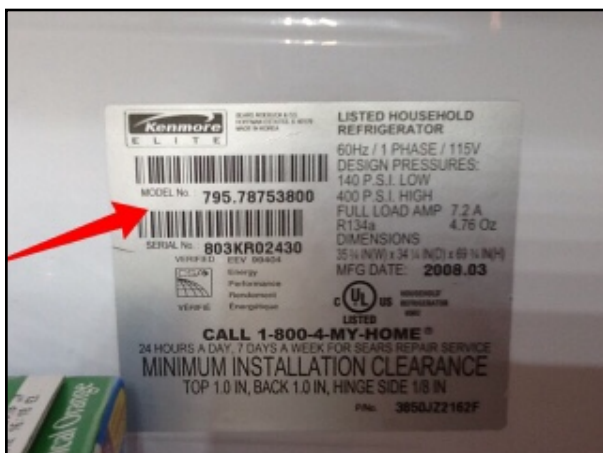
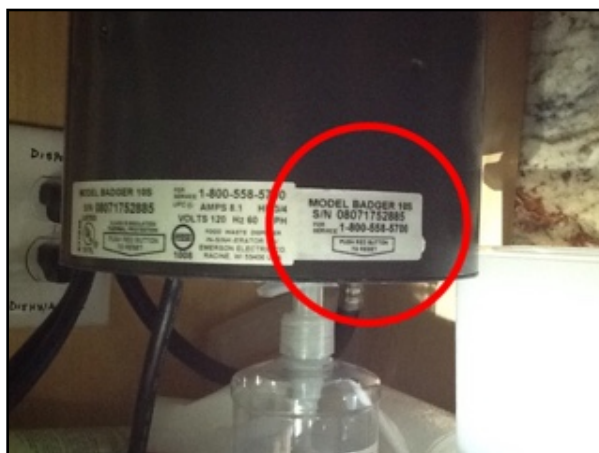
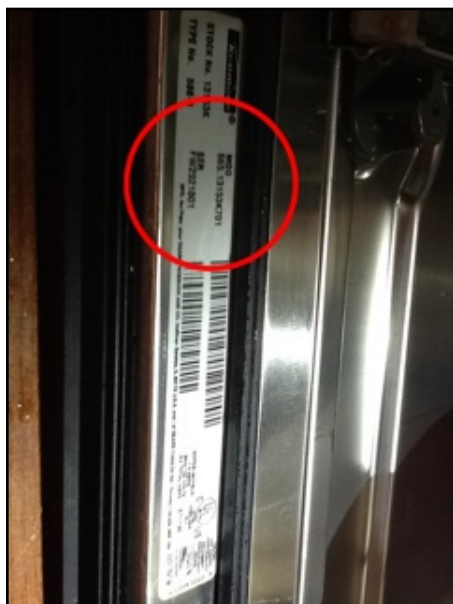
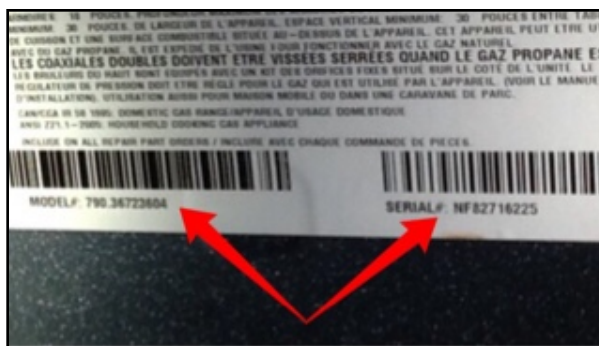
Refrigerator, garbage disposal, dishwasher, and oven model and serial number stickers.

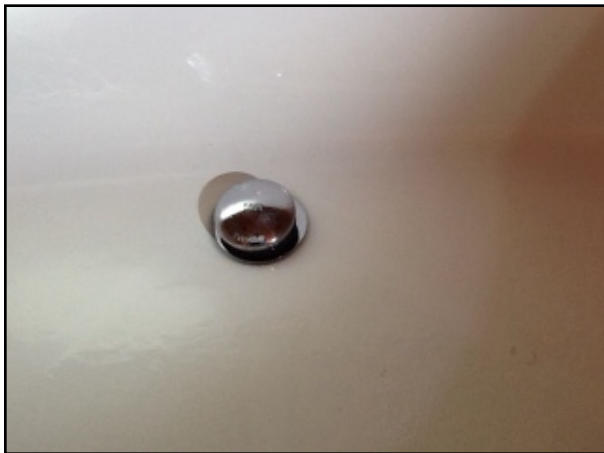
Figure 14-1

Bathtub plug does not seal. Will not retain water in tub. Recommend seeking licensed plumber to further evaluate and repair.

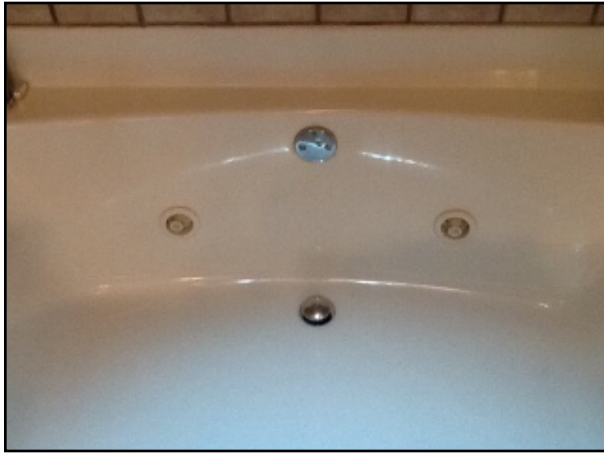
Figure 15-1

Unable to test jets adequately due to bathtubs inability to hold water in tub. Jets do turn on.

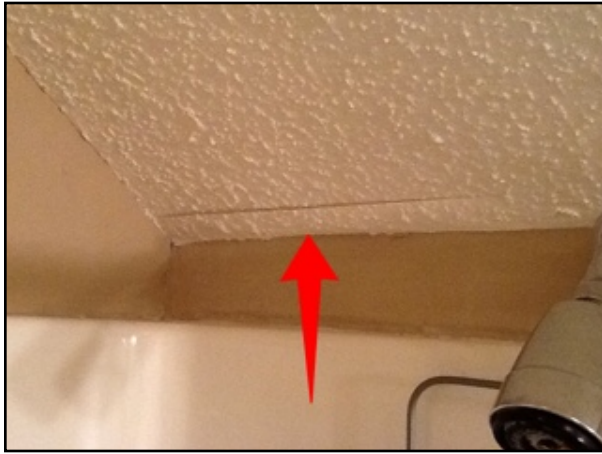
Figure 16-1

Dry wall tape is peeling on ceiling above shower. Cosmetic issue.

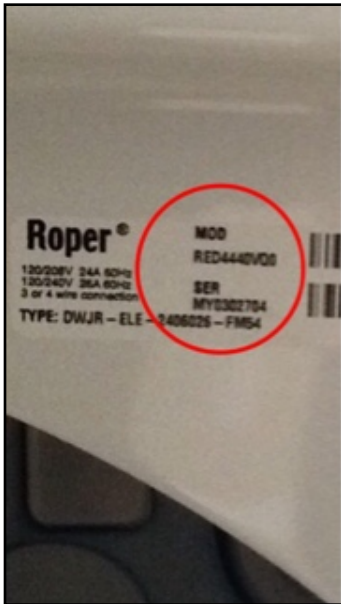
Figure 17-1

Dryer model and serial numbers. Washer numbers were unavailable

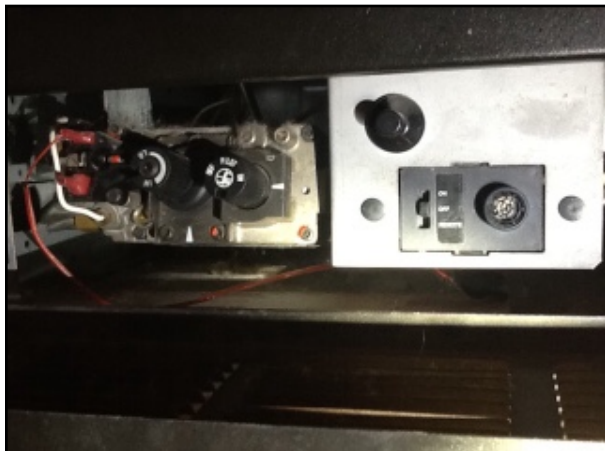
Figure 18-1

Gas fireplace controls. Presents remote control, however remote control was not available at time of inspection.

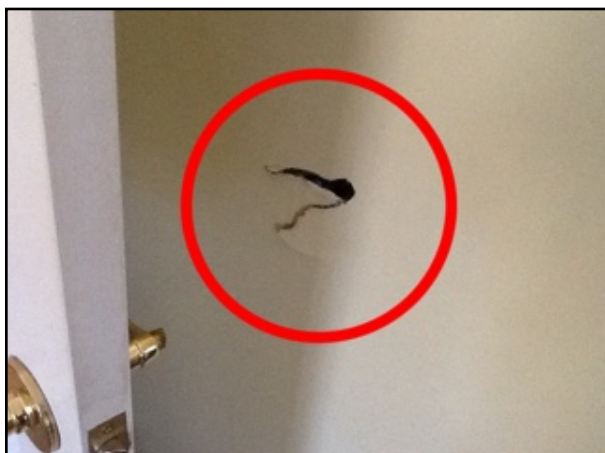
Figure 19-1

Master bedroom: hole in wall behind door. Wall currently has adequate door stopper preventing additional damage. Recommend seeking a licensed general contractor to further evaluate and repair.

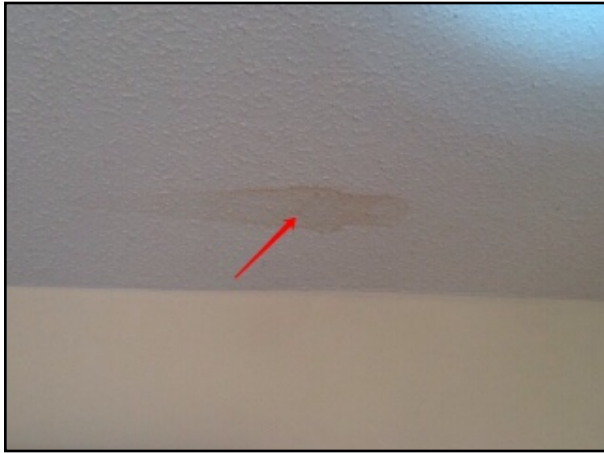
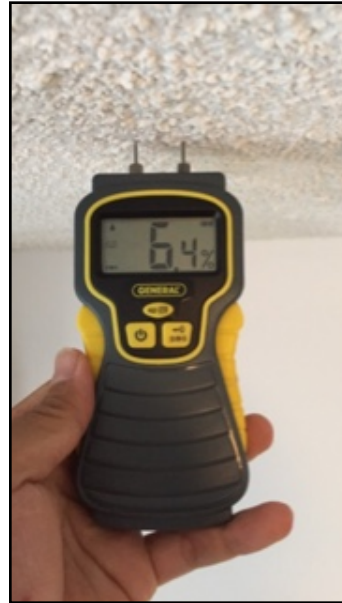
Water stain and cracking in upstairs bedroom ceiling . 6% moisture in accordance to moisture meter. Unable to gain access on other side to further assess. Recommend seeking licensed general contractor to further evaluate and repair.

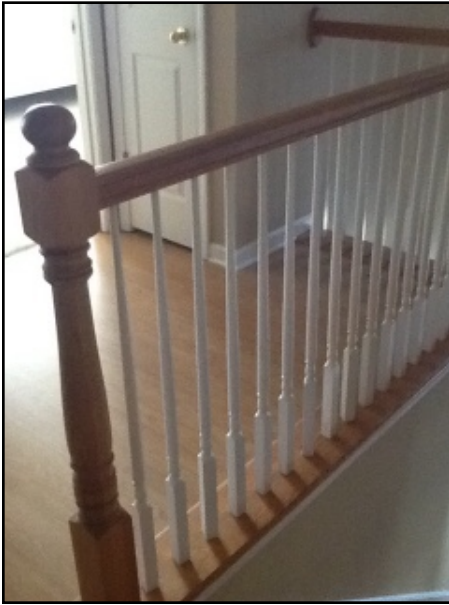
Figure 21-1

Upstairs railing moves tremendously when pressure is applied. Presents extreme safety concern. Recommend seeking licensed general contractor for further inspection and repair.

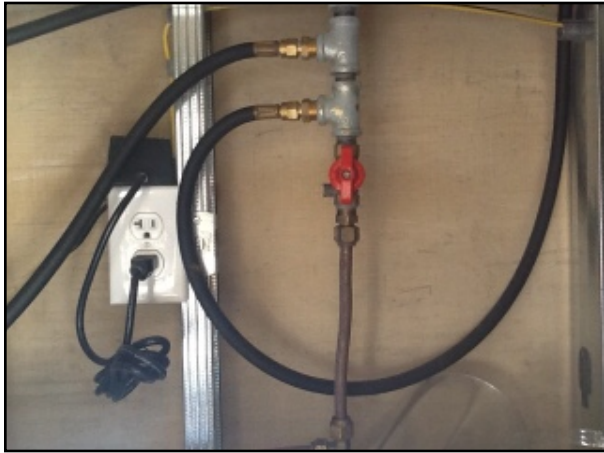
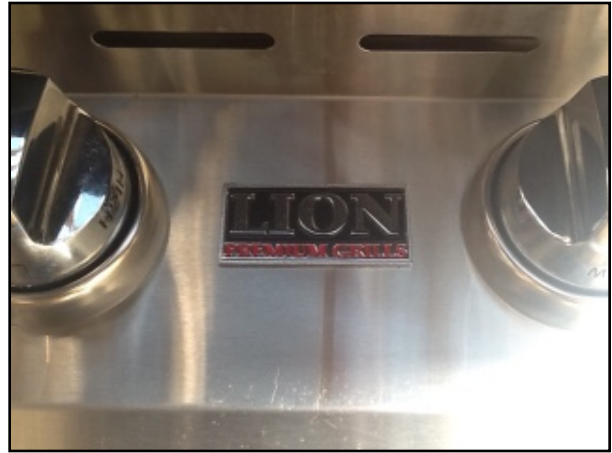
Electric and gas hook ups under grill. Brand of all outdoor appliances: Lion Premium Grills

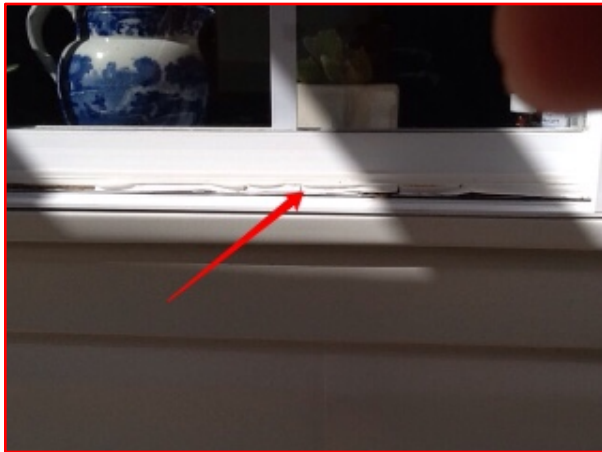
Figure 2-1

1) Weather stripping on exterior kitchen window is dried out and cracked. Recommend seeking licensed general contractor to further evaluate and repair.

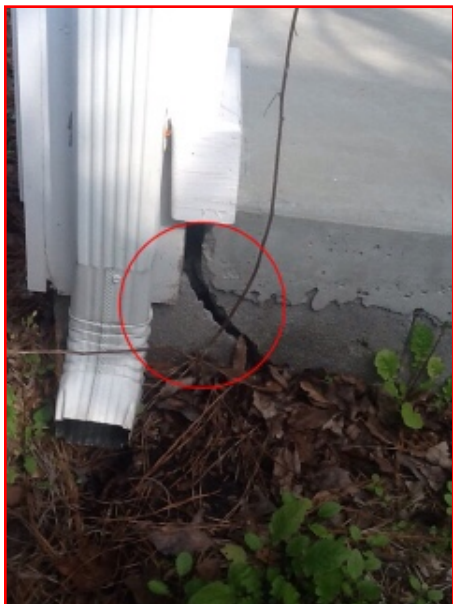
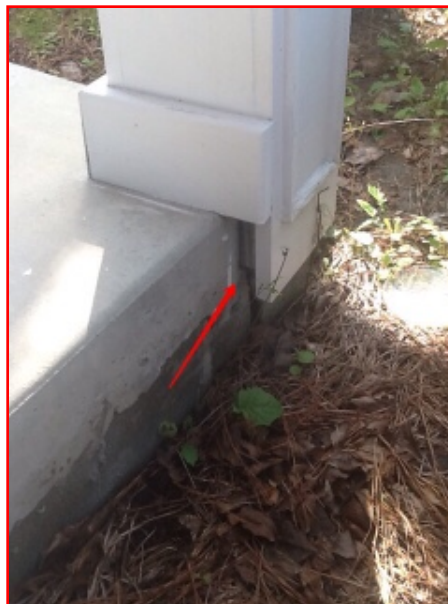
2) Outside front porch is cracked under load bearing column and is pulling away from main foundation. Located at farthest right column. Recommend seeking licensed general contractor to further evaluate and repair.

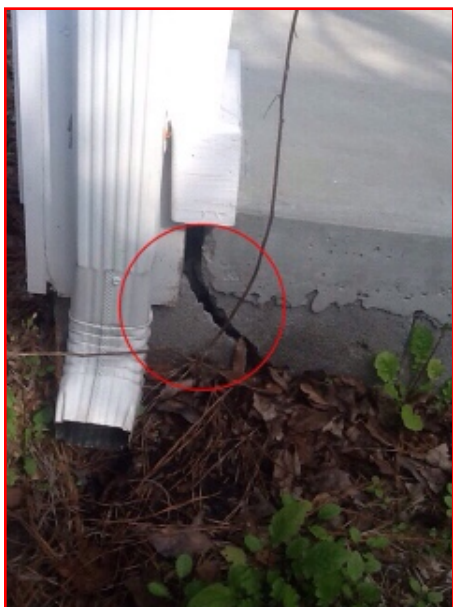
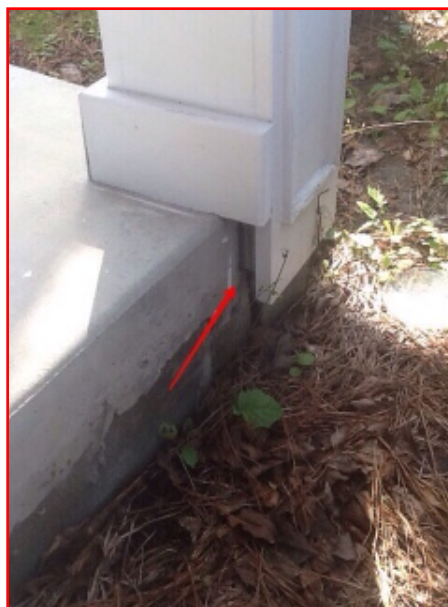
3) Outside front porch is cracked under load bearing column and is pulling away from main foundation. Located at farthest right column. Recommend seeking licensed general contractor to further evaluate and repair.

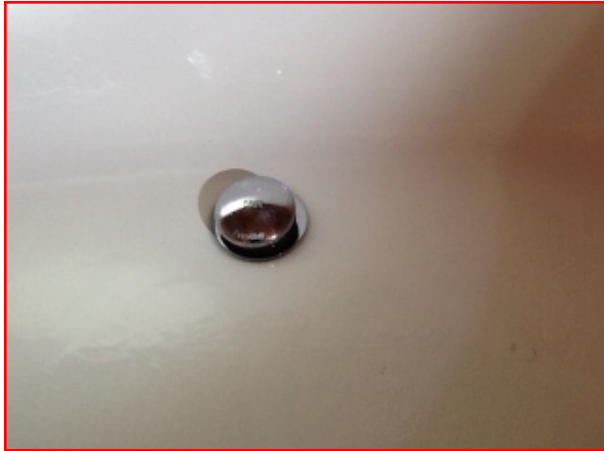
Figure 14-1

4) Bathtub plug does not seal. Will not retain water in tub. Recommend seeking licensed plumber to further evaluate and repair.

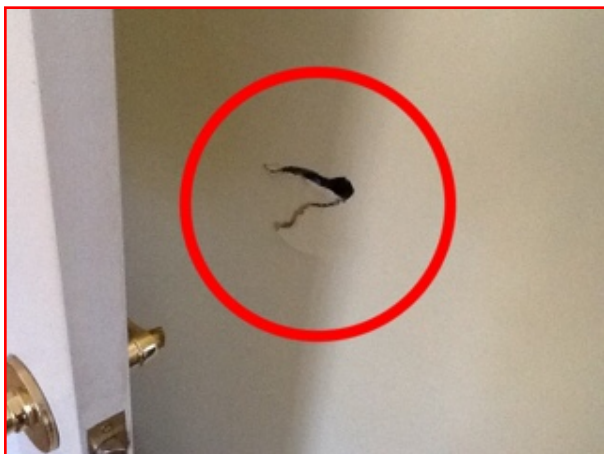
Figure 19-1

5) Master bedroom: hole in wall behind door. Wall currently has adequate door stopper preventing additional damage. Recommend seeking a licensed general contractor to further evaluate and repair.

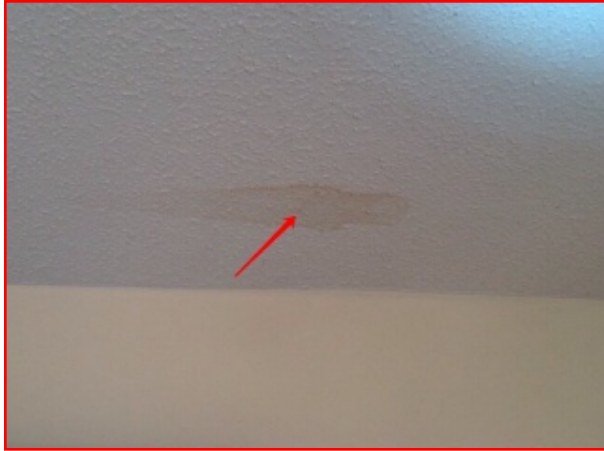
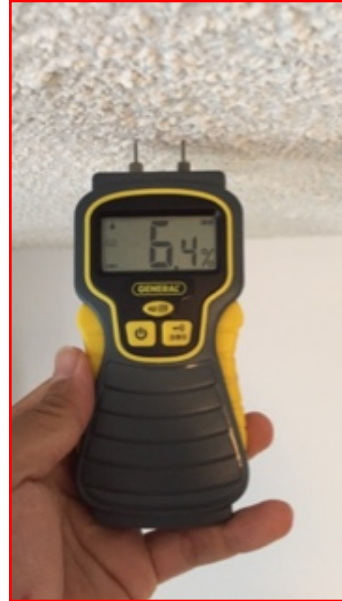
6) Water stain and cracking in upstairs bedroom ceiling . 6% moisture in accordance to moisture meter. Unable to gain access on other side to further assess. Recommend seeking licensed general contractor to further evaluate and repair.

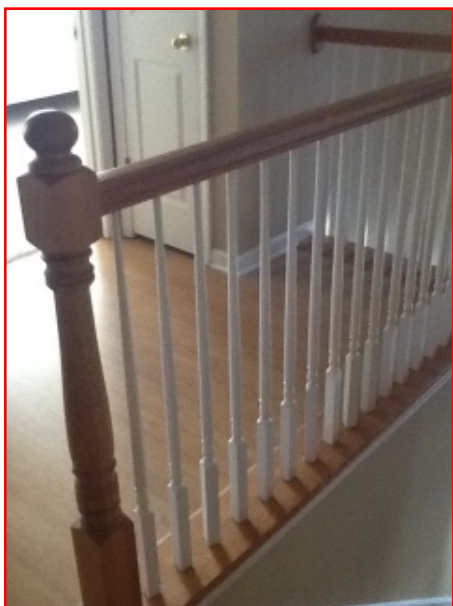
Figure 21-1

7) Upstairs railing moves tremendously when pressure is applied. Presents extreme safety concern. Recommend seeking licensed general contractor for further inspection and repair.
